REPAIRING ALUMINUM WIRING

Publication 516

ALUMINUM WIRING

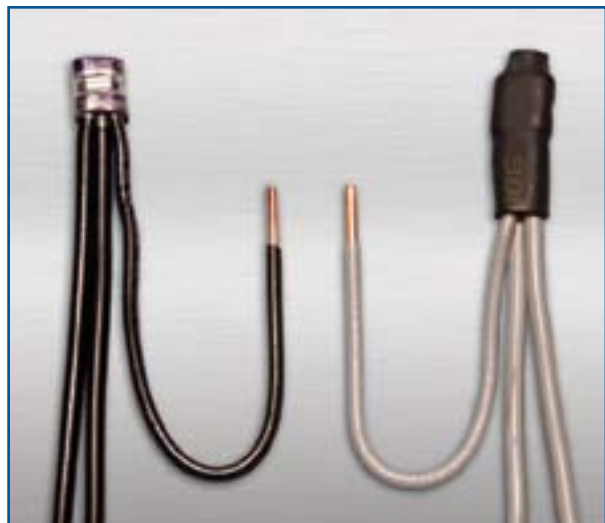
The COPALUM connector is a specially designed system that includes a metal sleeve intended to be installed only with a dedicated power tool and crimping die to make a permanent connection, that is, in effect, a cold weld (the precision dies in the COPALUM tool compress the connector and wires using upwards of 10,000 pounds of force, as required to make the permanent aluminum wire connection).
